**MARYLAND HISTORICAL TRUST
NR-ELIGIBILITY REVIEW FORM**

Property Name: Henry S. Michael Farm Inventory Number: F-1-087

Address: 2231 Point of Rocks Road City: Adamstown Zip Code: 21710

**MARYLAND HISTORICAL TRUST
NR-ELIBILITY REVIEW FORM**

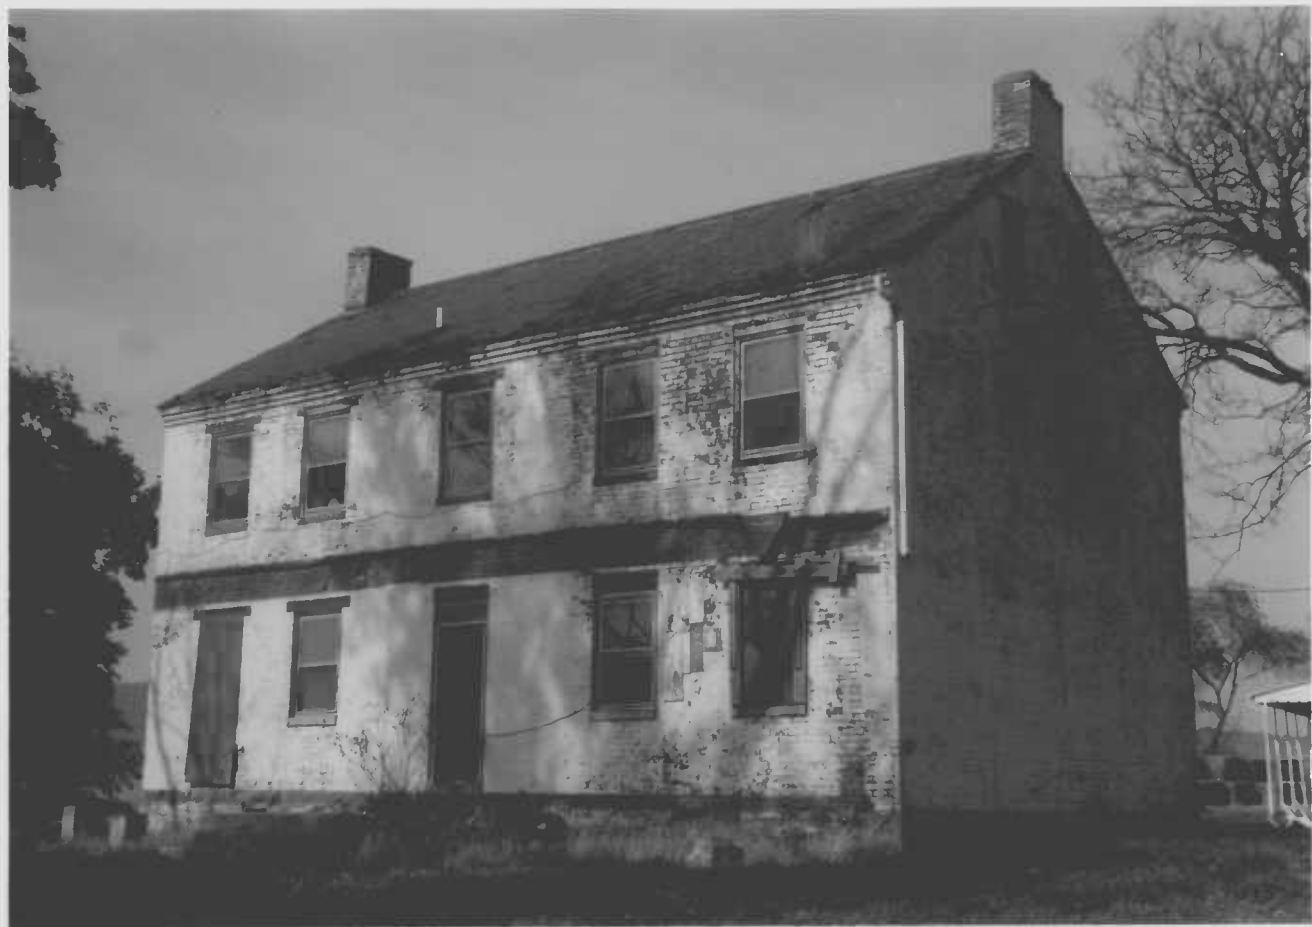
1 OF 10

Since initially surveyed 1979, the main house exterior has undergone few changes. The five-bay, two-story, common-bond brick dwelling retains its exterior character-defining features of massing, design, and ornamentation. The windows feature original exterior decorative molded wood lintels with exterior projecting corner blocks. The one-story frame porch has been removed from the front (south) façade and west side and a dilapidated wood stoop with concrete steps was added along the west side. The wood-frame windows are the same as in 1979. Interior inspection of the window sashes revealed prior alterations resulting in the removal of all muntins and installation of larger panes of glass. Exterior aluminum storm windows have been added. One of door openings on the west elevation has been infilled.

FACING NORTHWEST SOUTHEAST ELEVATION

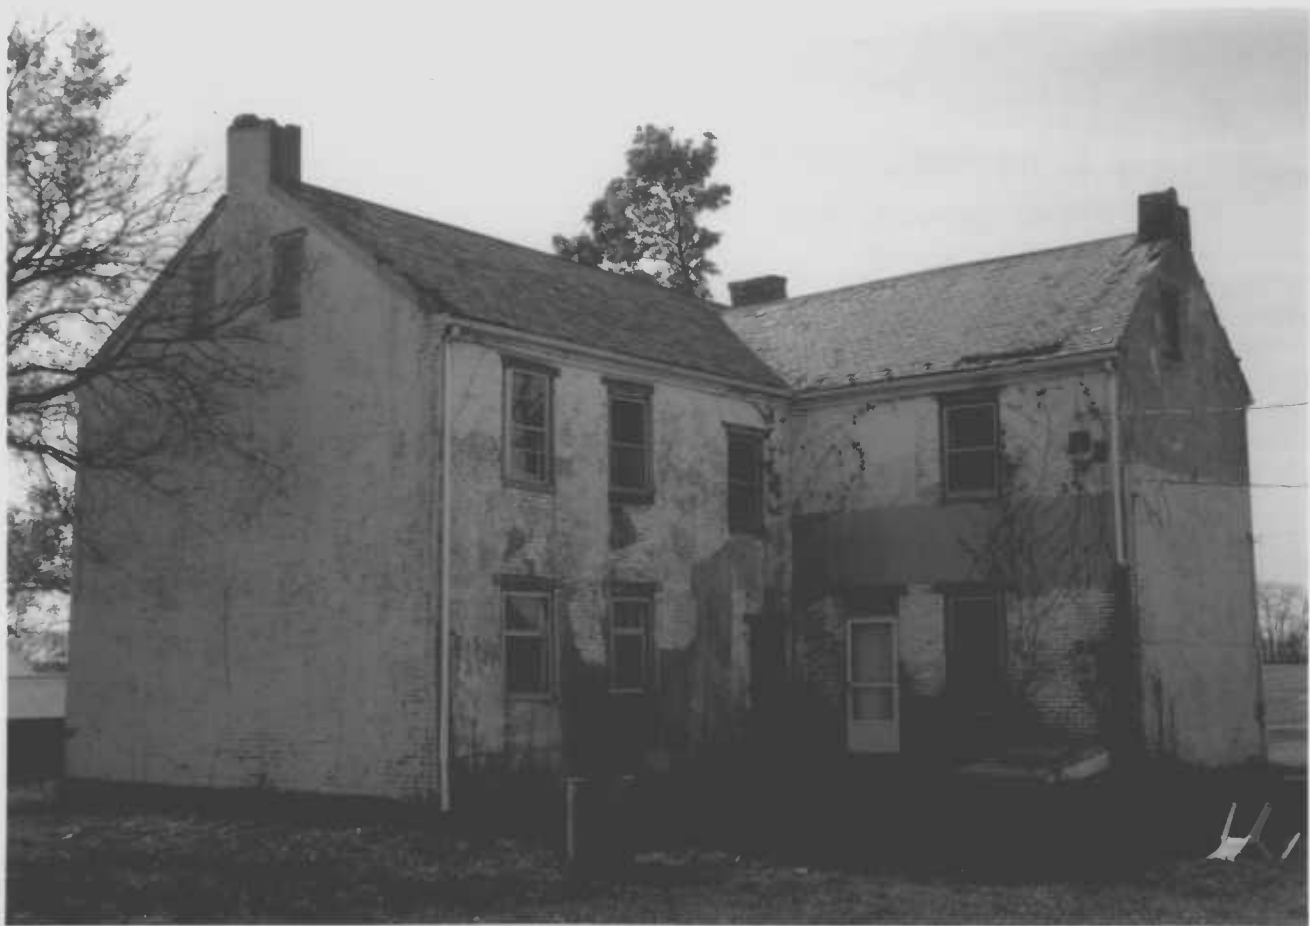
2 OF 10

VIEW SOUTHWEST NORTHEAST ELEVATION

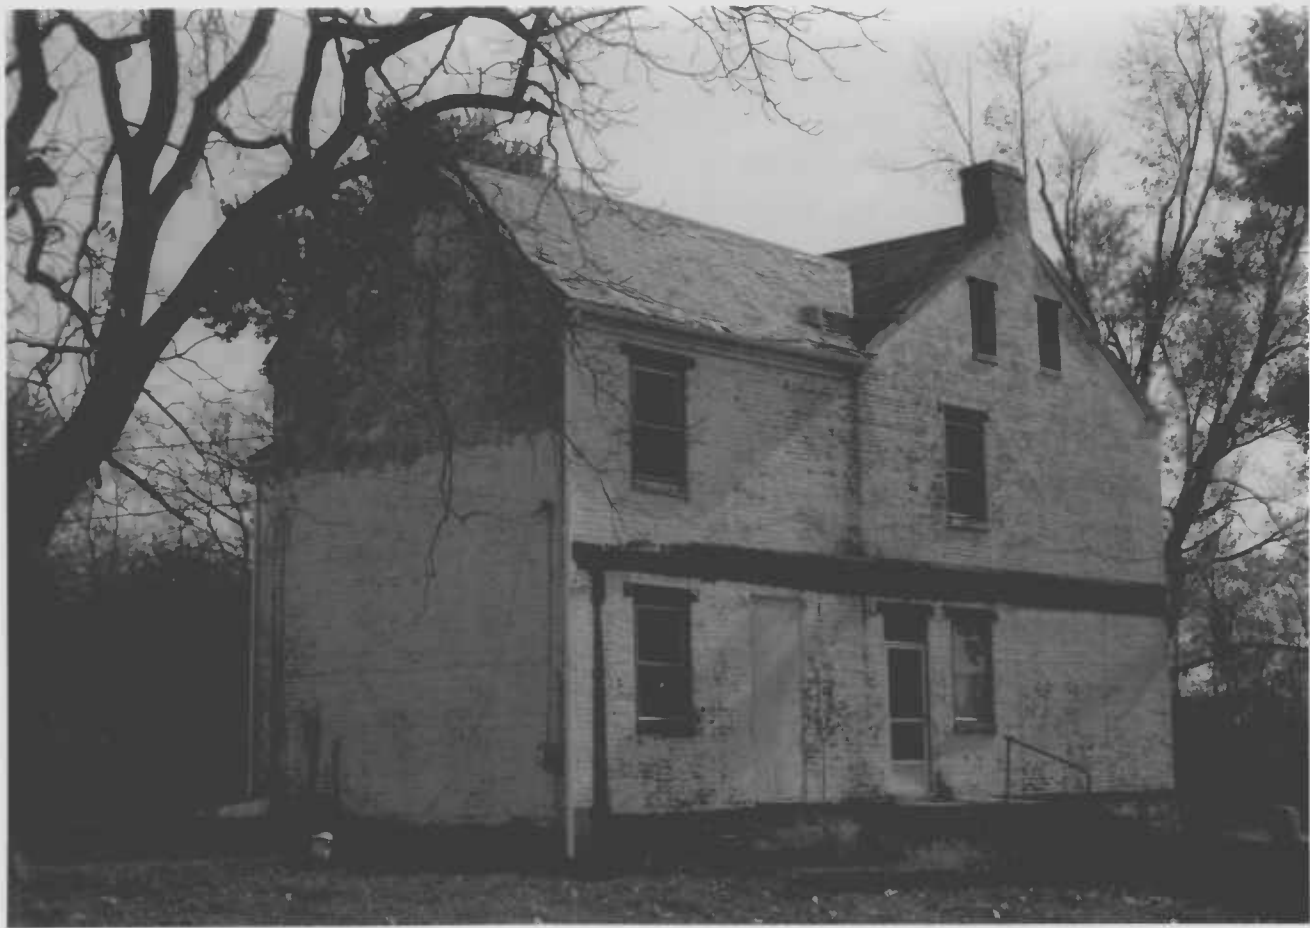
3 OF 10

VIEW ~~SOUTHEAST~~ ~~NORTHWEST~~ ELEVATION

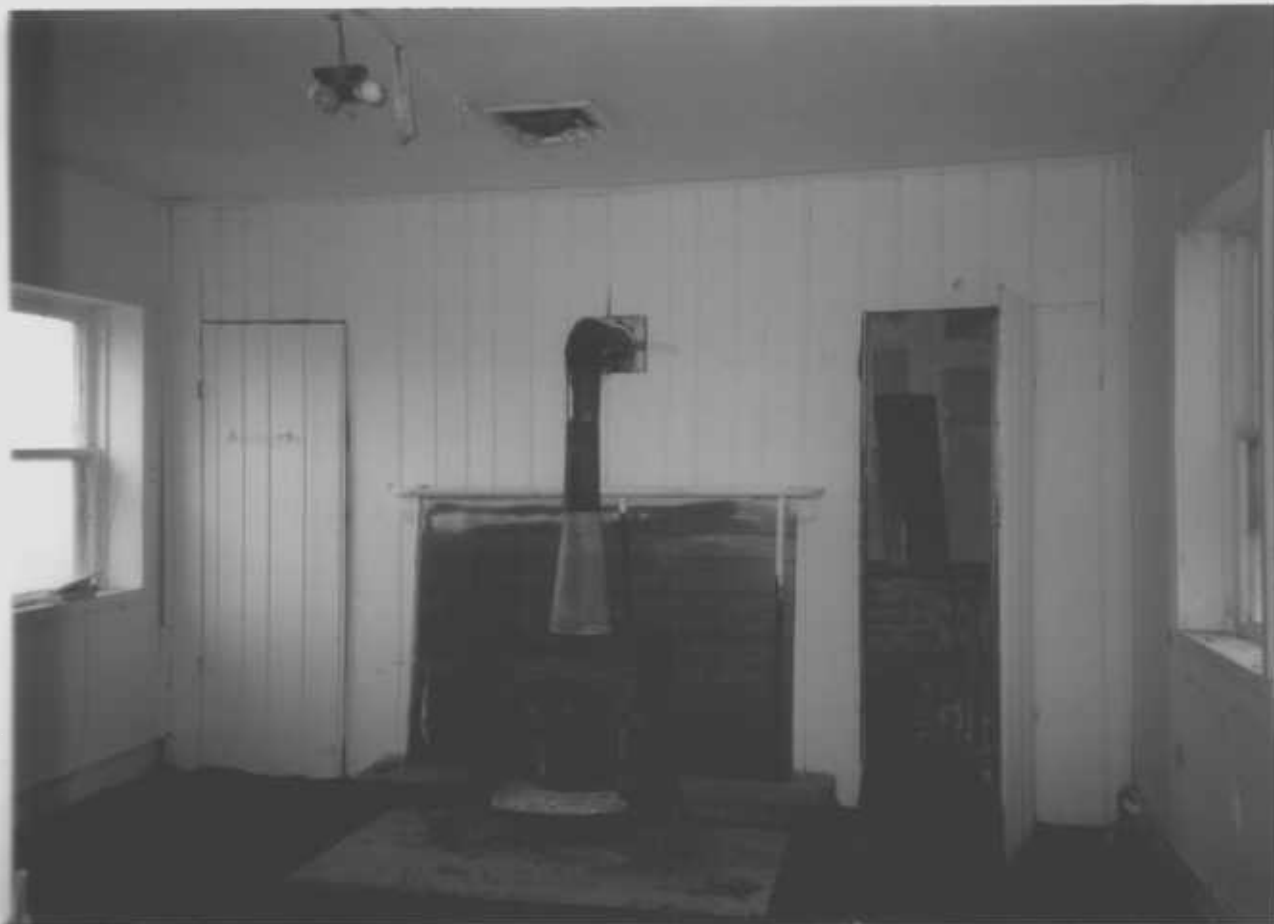
4 OF 10

The kitchen occupies the rear ell. The rear wall that contains the fireplace features a beaded board wall. The fireplace has been altered and a wood stove installed. The exterior door to the west was infilled and the opening hidden behind modern kitchen cabinets and sink.

DETAIL OF WOOD STOVE OF INTERIOR OF KITCHEN
LOOKING NORTH

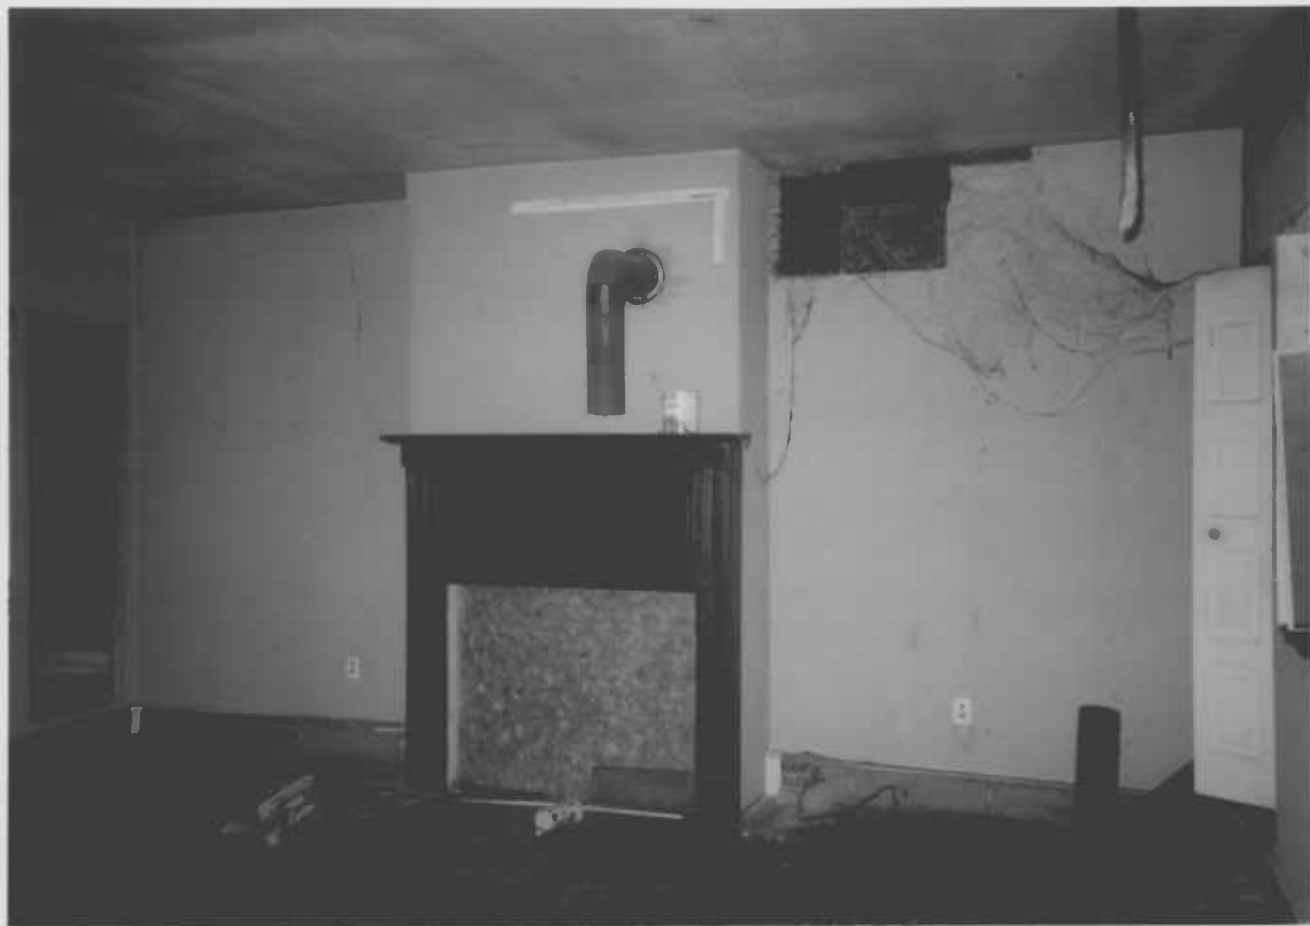
5 of 10

The house interior features a central hall floor plan. The central hall features an open staircase with a landing. The stair stringers are ornamented with jigsawn scrollwork. The handrail is solid wood and round. The newel posts are turned with square bases and the balusters are square. No original molding or surrounds were visible during inspection of the interior since all the interior walls have been covered with sheetrock. Minor alterations to the floor plan were evident. The first floor east room has new walls inserted into the space to provide storage areas. The first floor room west of the central hall has been subdivided into a bathroom, a storage closet, and a living room. The chimneys remain in their original locations; however, alterations have been made to the hearths and mantels to accommodate the installation of stoves. The mantel of the living room fireplace was poorly built from modern materials.

DETAIL OF FIRE PLACE ON
FIRST FLOOR EAST ROOM
LOOKING EAST

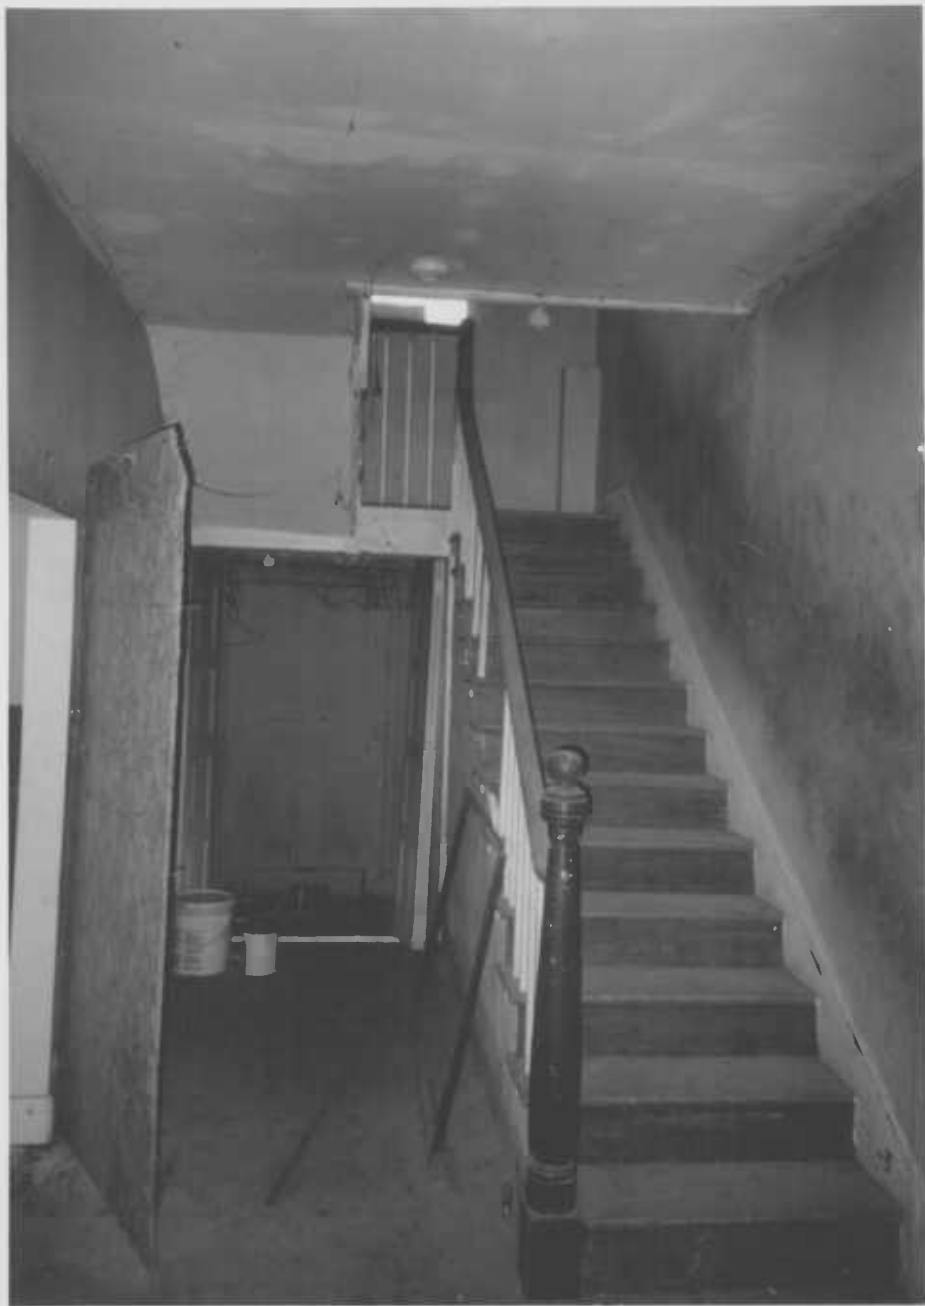
6 OF 10

DETAIL OF STAIRWELL VIEW NORTH

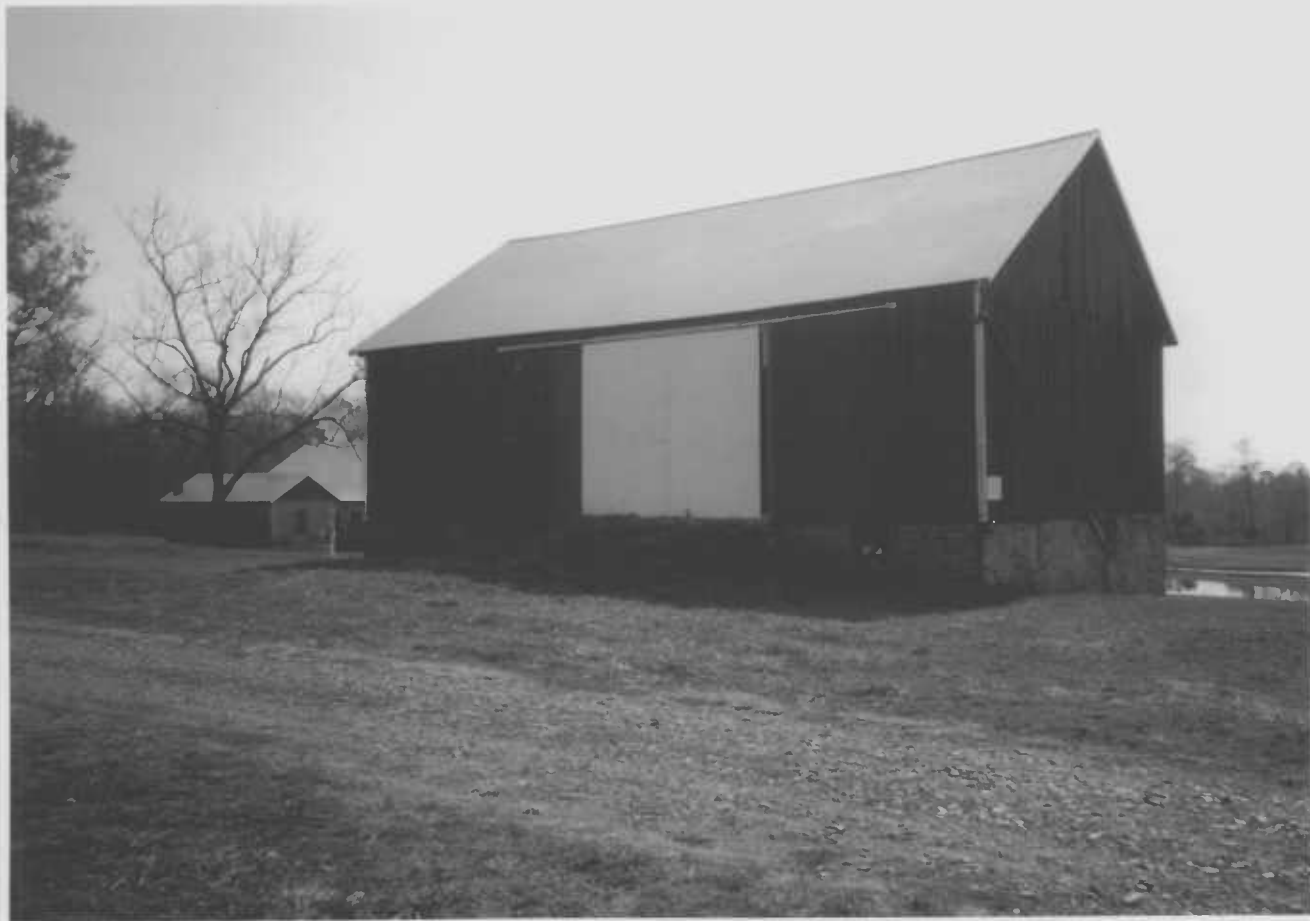
7 OF 10

The agricultural outbuildings currently comprise a barn, a milk house, and a milking parlor. The brick outbuilding located at the rear of the dwelling as described in the 1979 MIHP form was removed. The bank barn with closed forebay is supported by a rubble stone foundation and H-bent framing. The walls are clad with vertical board siding. A sliding wood door is located on the banked (north) elevation. The gable roof is sheathed with a new standing seam metal roof. The interior of the barn is divided into four bays: a mow with two raised mows on the east and a raised mow on the west. The age of the upper wood superstructure of the barn appears to date from ca. 1900, but the foundation probably dates from ca. 1880.

BANK BARN LOOKING SOUTHEAST,

NORTH AND WEST ELEVATIONS

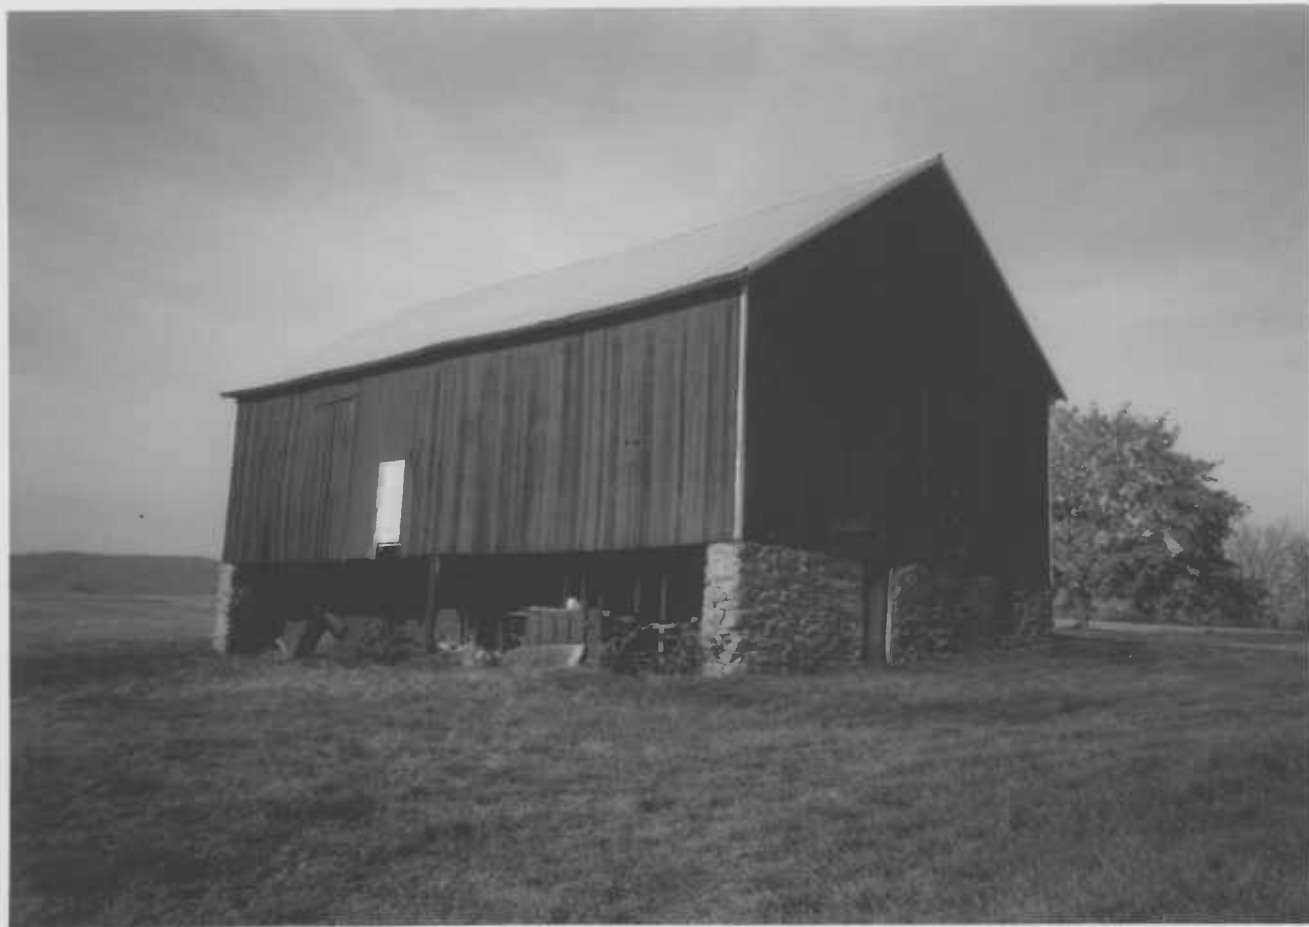
8 OF 10

BANK BARN LOOKING NORTHWEST

SOUTH AND EAST ELEVATIONS

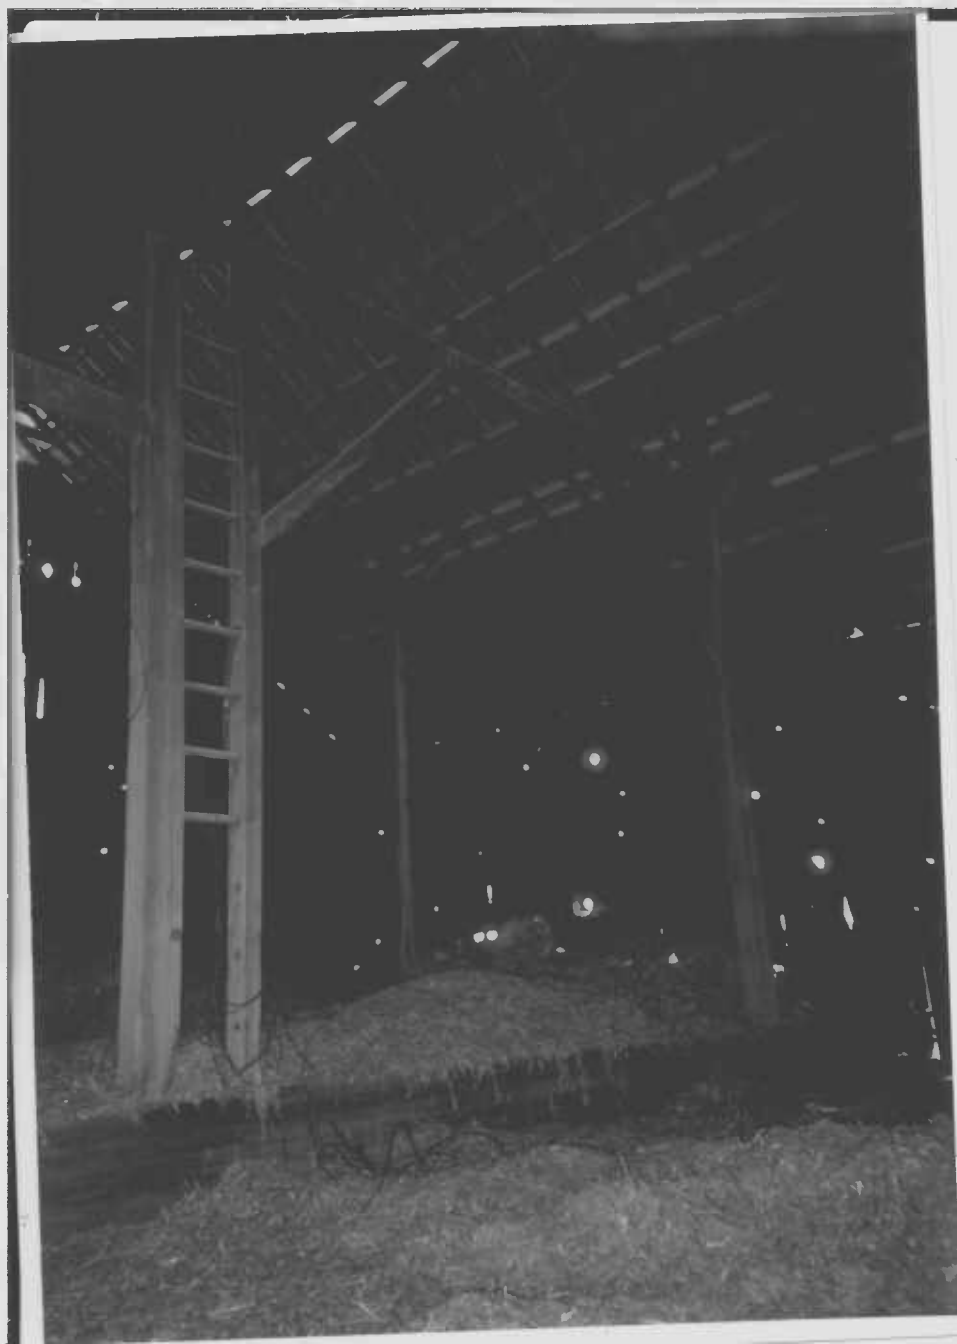
9 OF 10

BANK BARN INTERIOR VIEW EAST

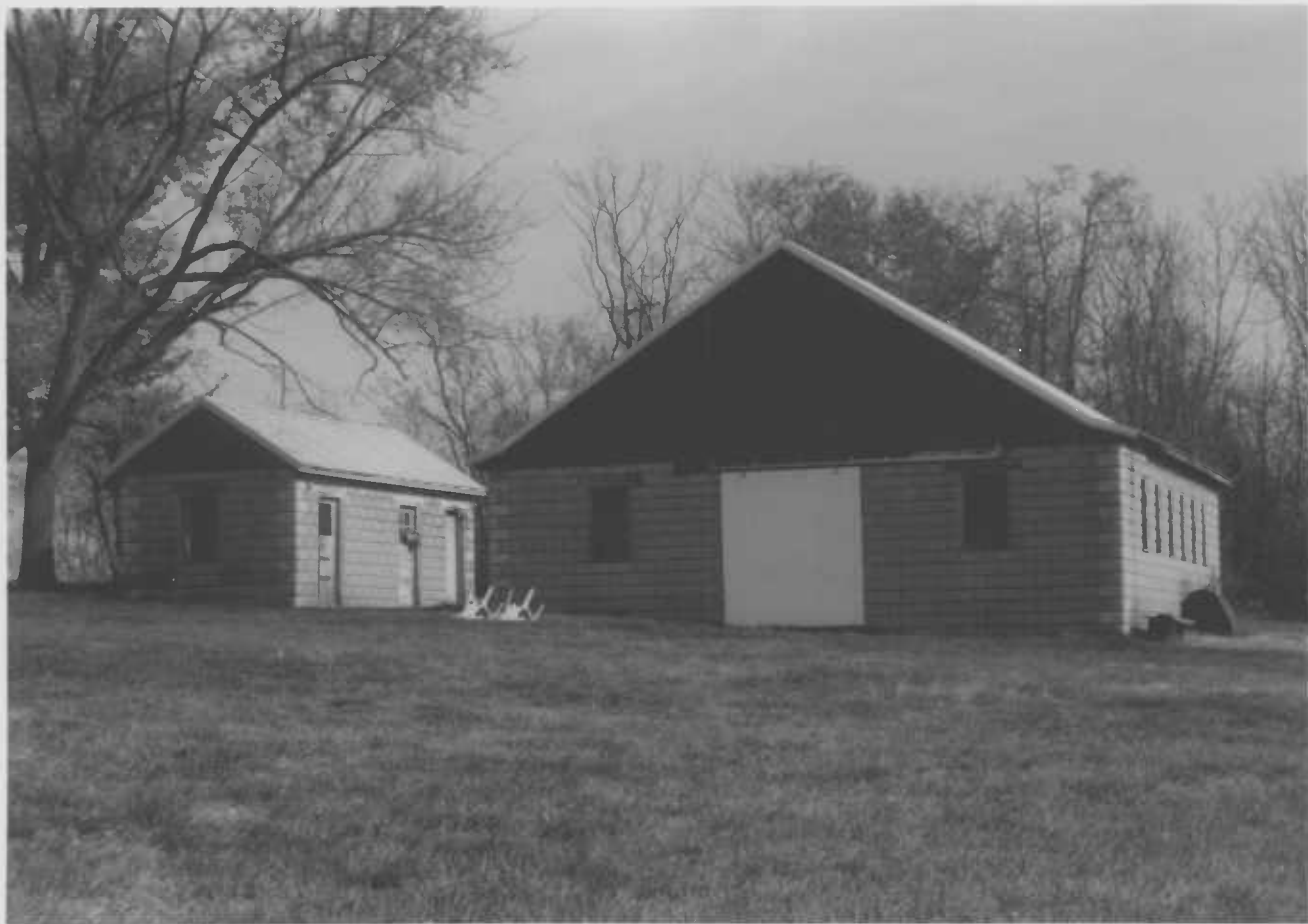
10 of 10

The ca. 1930, one-story, rectangular dairy rests on a concrete slab. The walls are constructed of concrete blocks and the building terminates in a gable roof sheathed with new standing seam metal. The building has two, three panel, wood doors and a vertical board door opening on the south side. Most window openings are boarded over except for one two-over-two-light window on the east end.

The ca. 1930, two-story, rectangular milking parlor rests on a concrete slab with troughs. The walls are concrete block and the building terminates in a gable roof sheathed with new standing seam metal. The building has sliding wood doors on the east and west ends and a single door opening on the north elevation. The windows are covered with corrugated metal.

ca. 1930 BARN S FACING EAST WEST ELEVATIONS

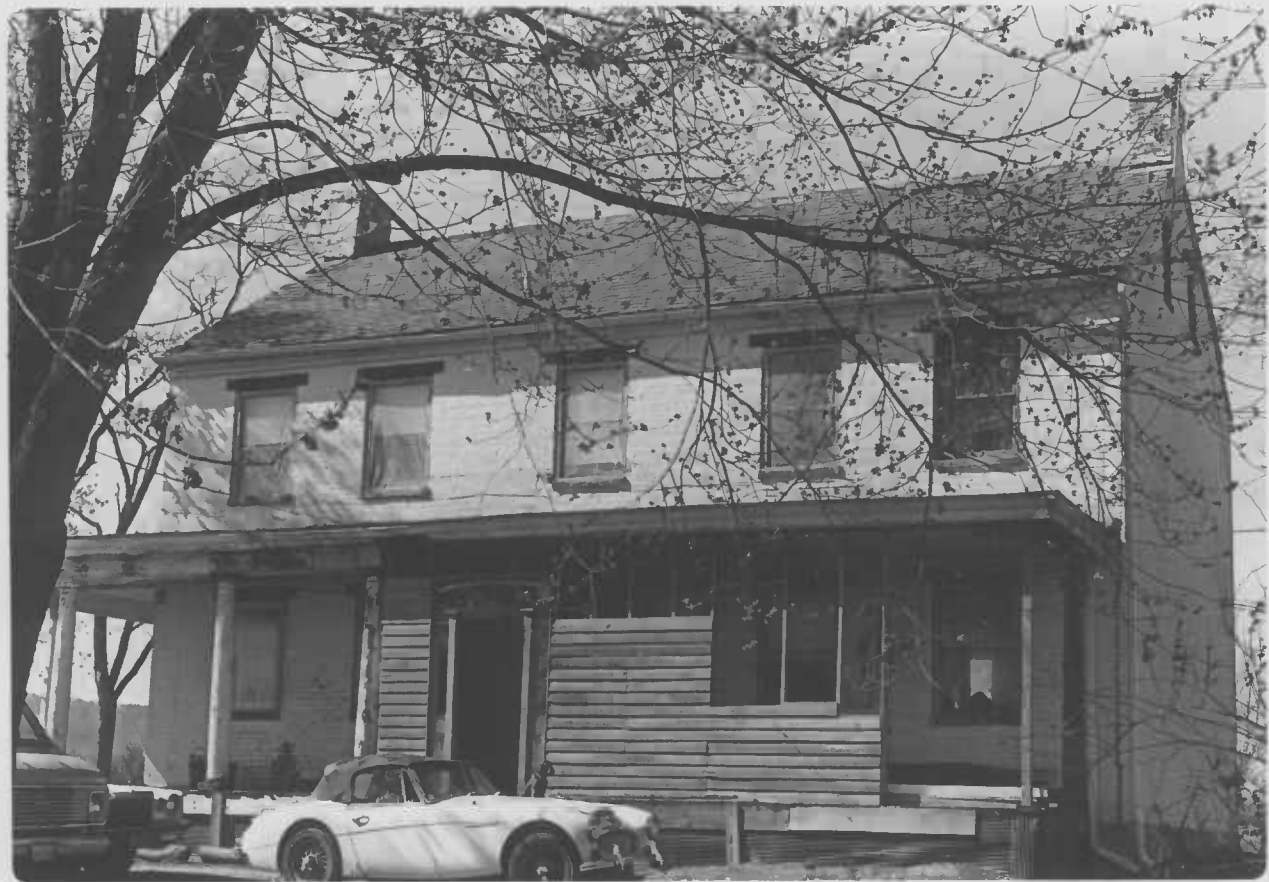
The principle facade is five bays wide. The main entrance, a replaced door with three light transom is located in the third bay.

Occupying the remaining bays on the first and second level are 1/1 and 2/2 double hung windows with single wood lintels with hipped corner blocks.

A one story frame porch which has been altered and partially enclosed by the addition of novelty siding extends across the entire facade (south side) of the building and west side of the building which is three bays wide.

CEW 8/78 SOUTH ELEVATION

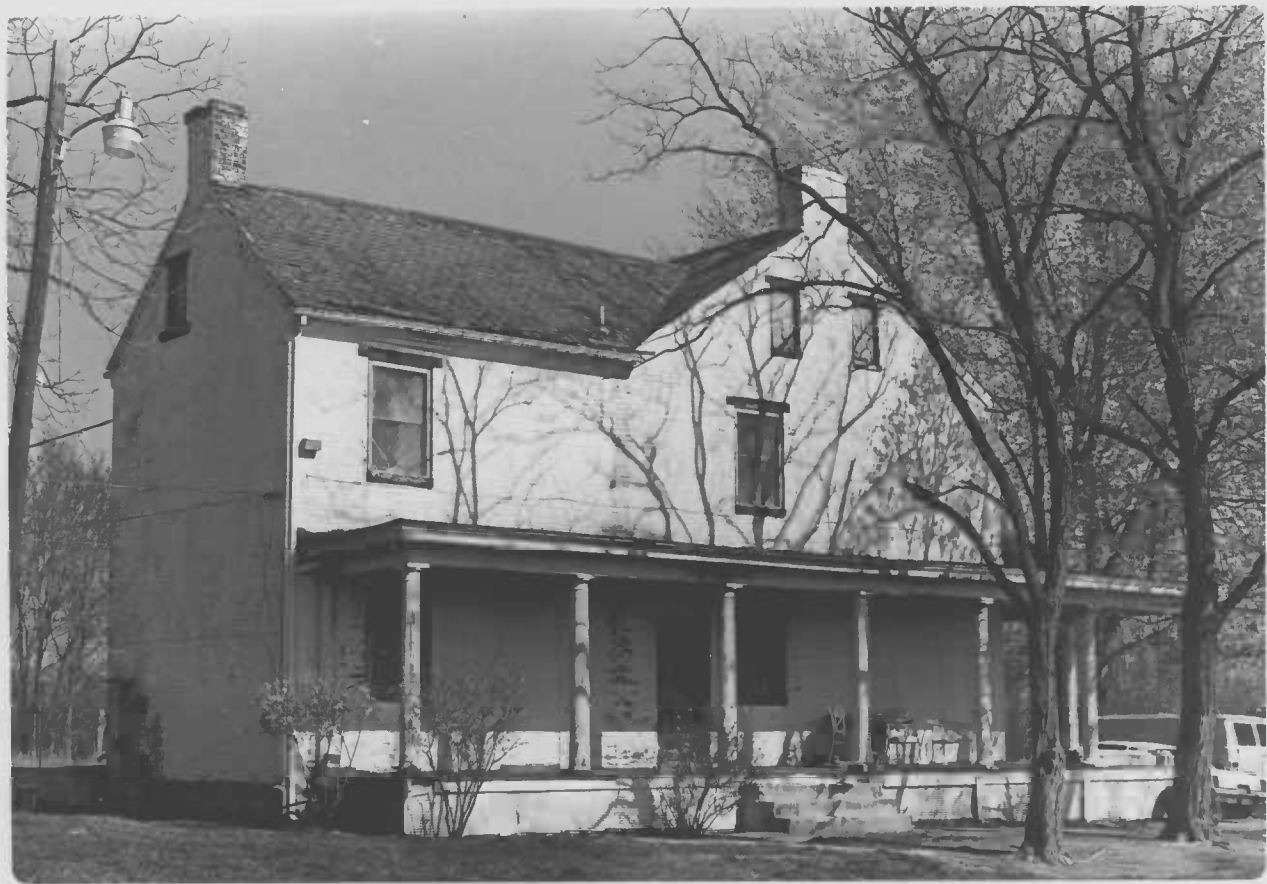
HIST ELEVATION

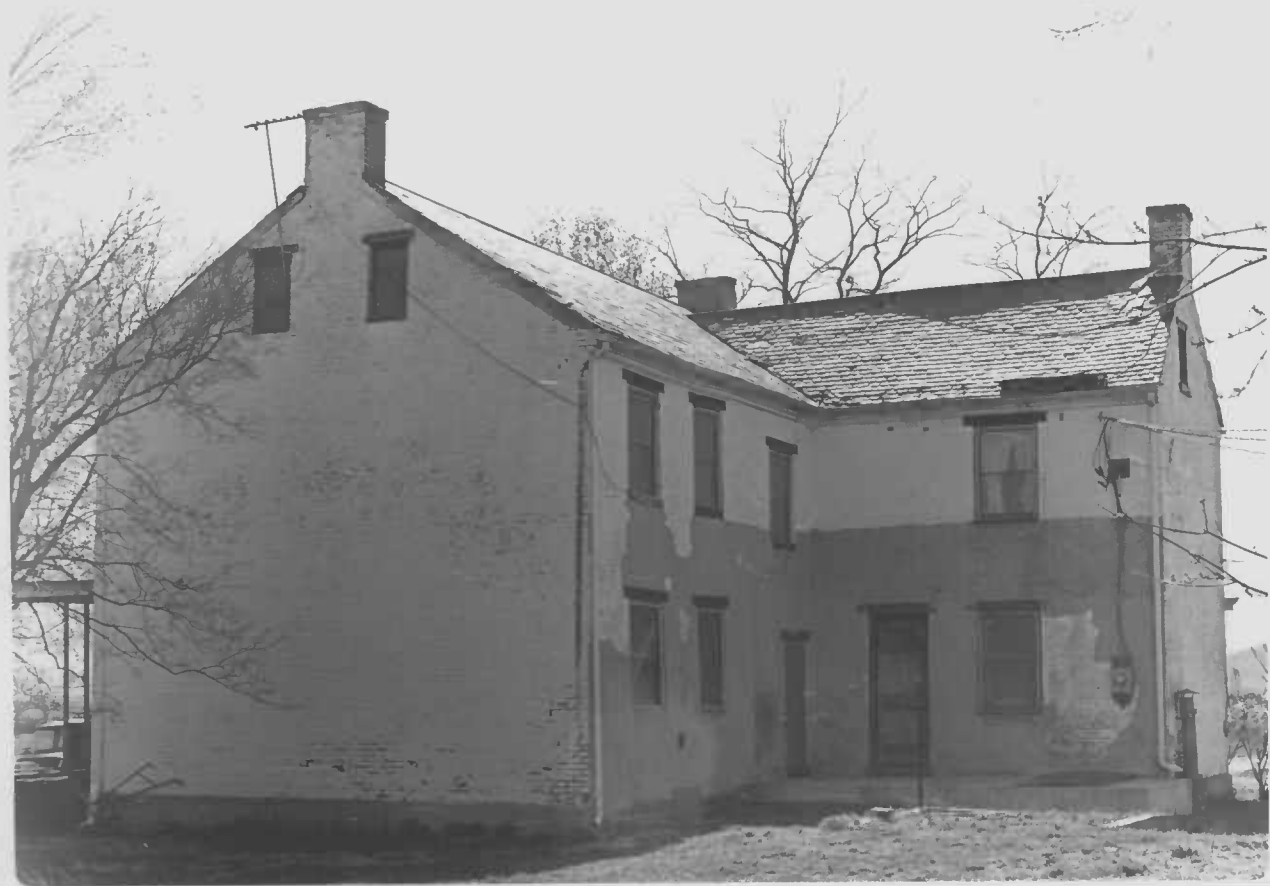
A two story addition, which appears to date to the same time as the main block of the building extends to the rear of the main block. The rear side of the main block of the building is three bays wide and the addition is two bays wide. The entire first level of the rear side of the building is stuccoed.

NORTH ELEVATION

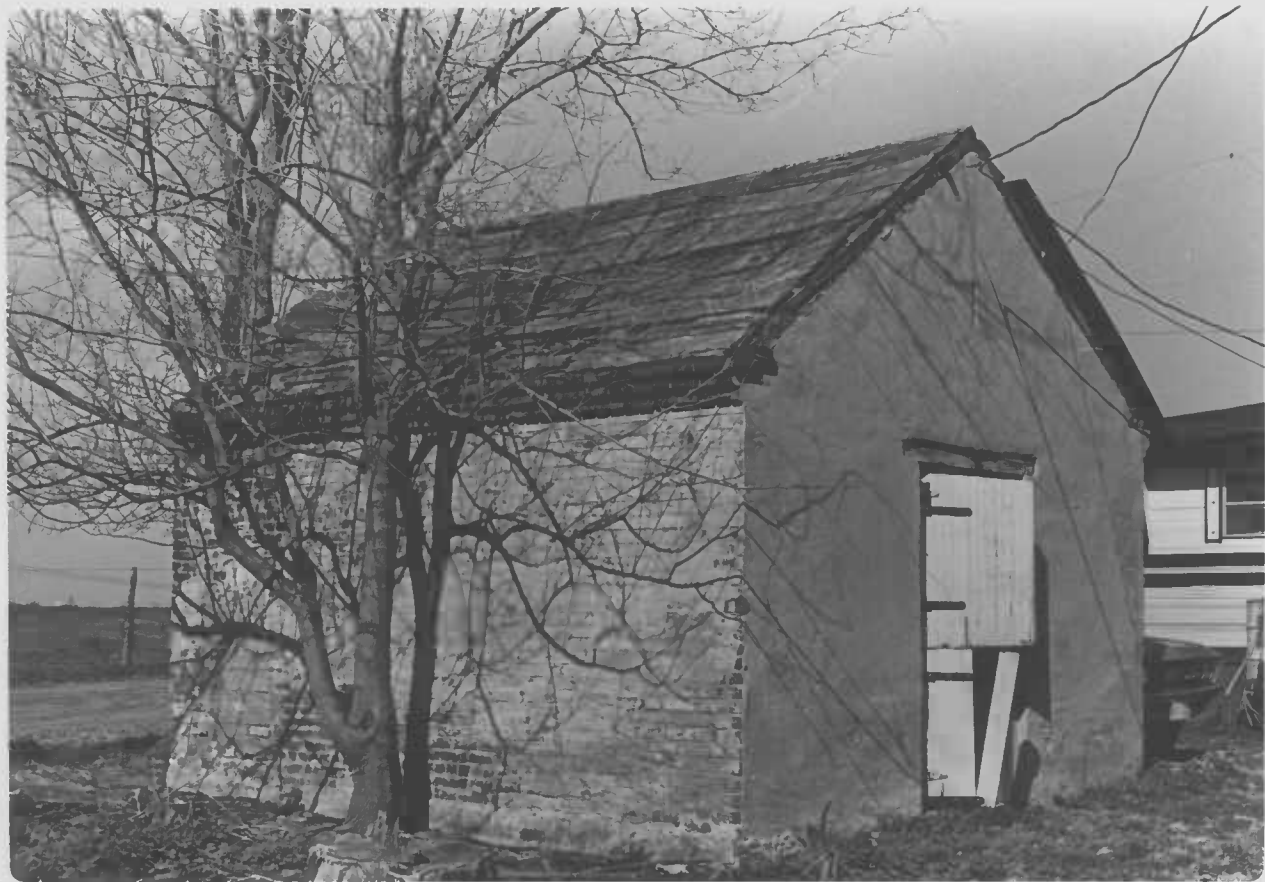
An outbuilding constructed of brick laid in common bond with a three stepped brick cornice and replaced roof is located to the rear of the building. The front of the outbuilding is stuccoed with a single air vent slit in the center of the gable. A large wood lintel is located over the entrance. The use of bricks in the construction of an outbuilding is unusual in Frederick County. A nineteenth century frame bank barn is also located on the premises.

OUTBUILDING
